Forensic Engineering and Visualization

July 20, 2020

RE: *Crash Reconstruction for Sines v. Kessler*

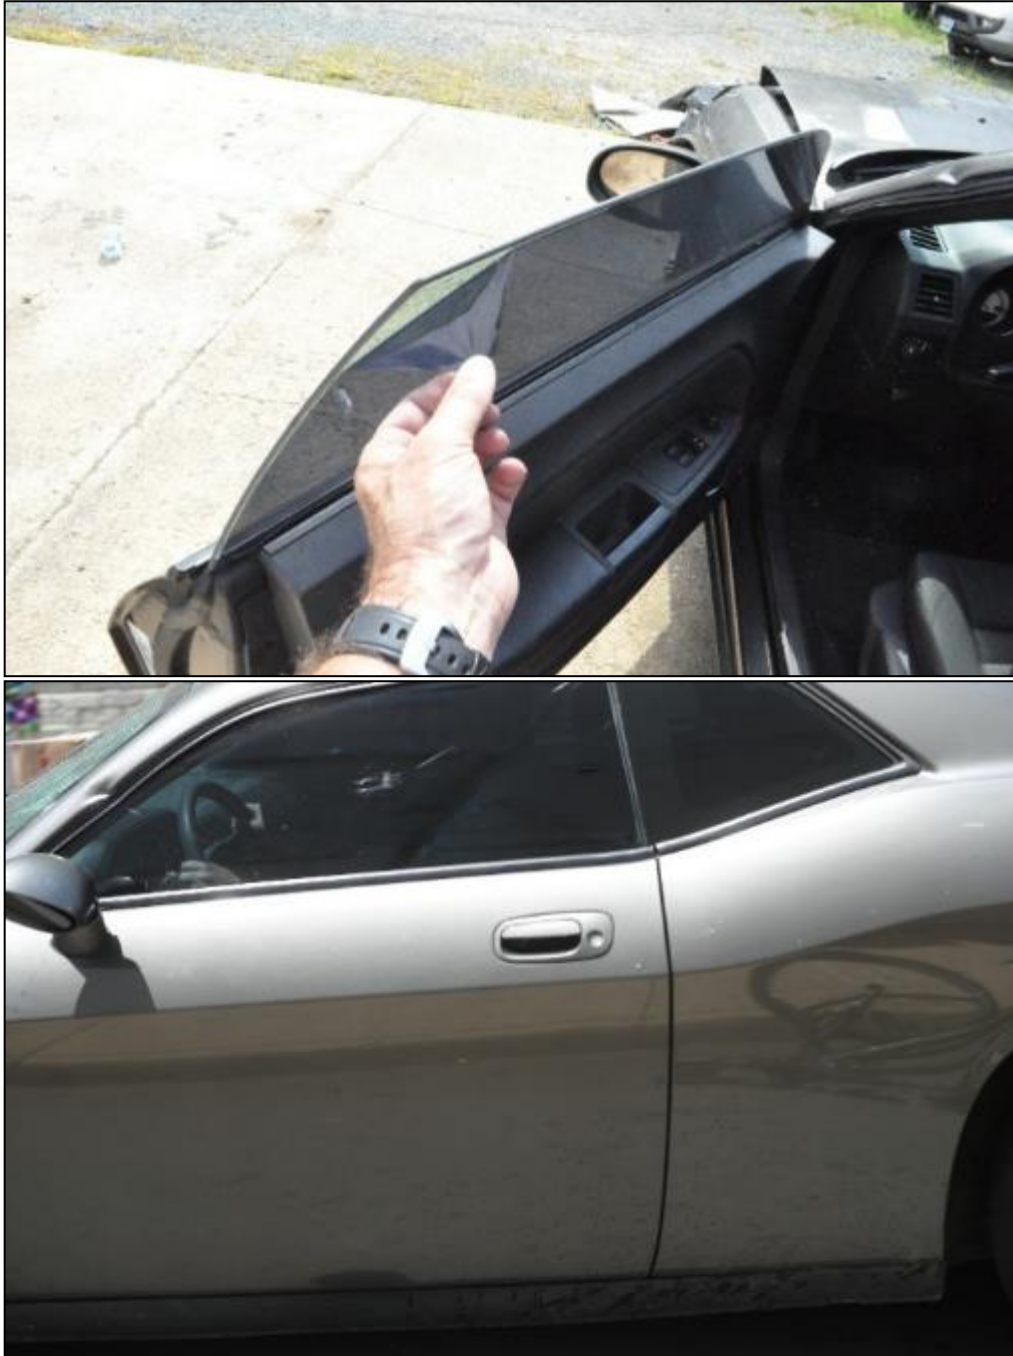
It was determined during the inspection that the driver and passenger side windows were tinted. As seen in the bottom photograph below taken at the time of the crash, the tinting made it difficult to see inside the Challenger.

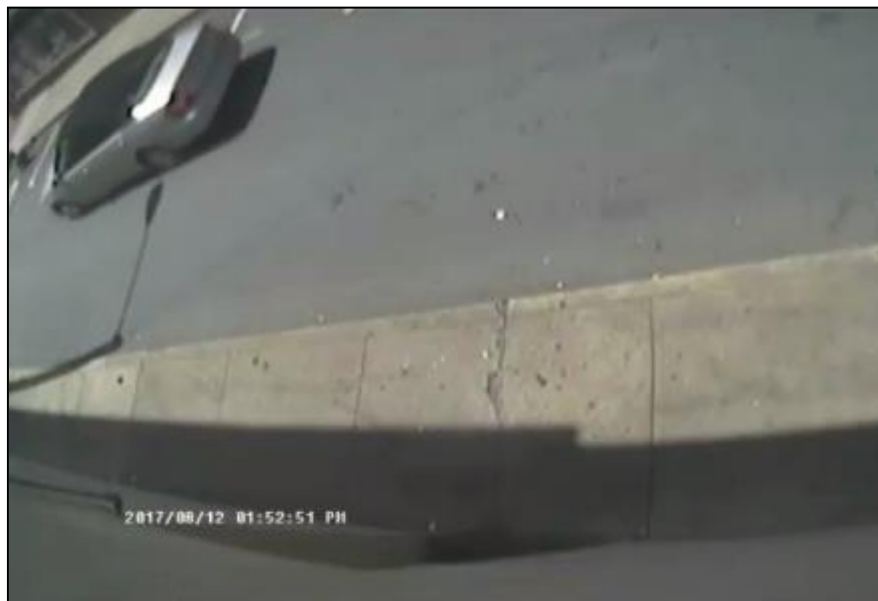
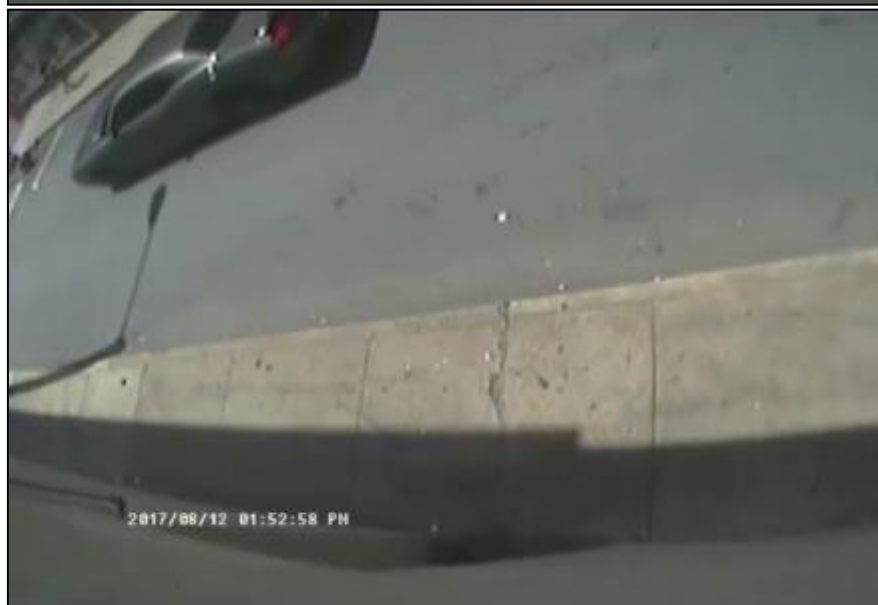
- a. The Red Pump video shows the Challenger followed the Camry down Fourth Street at approximately 1:52 p.m. (time not adjusted to the time in the CFS Report).

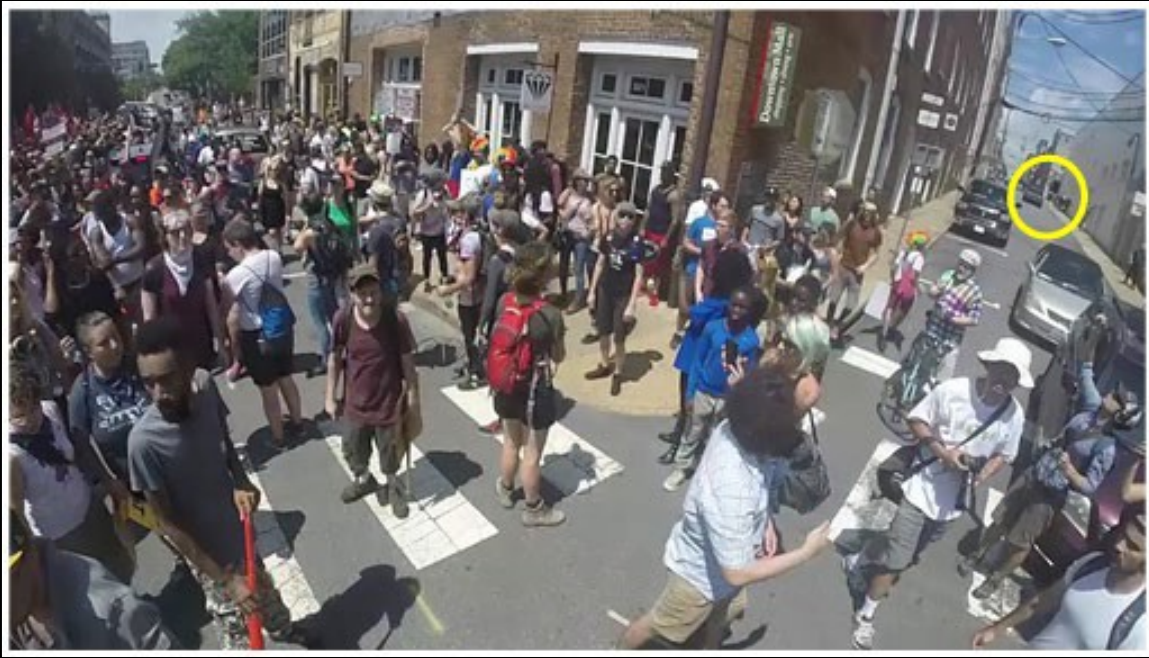
- b. The Challenger crossed Main Street and stopped just south of several newspaper boxes seen on the east side of Fourth Street.

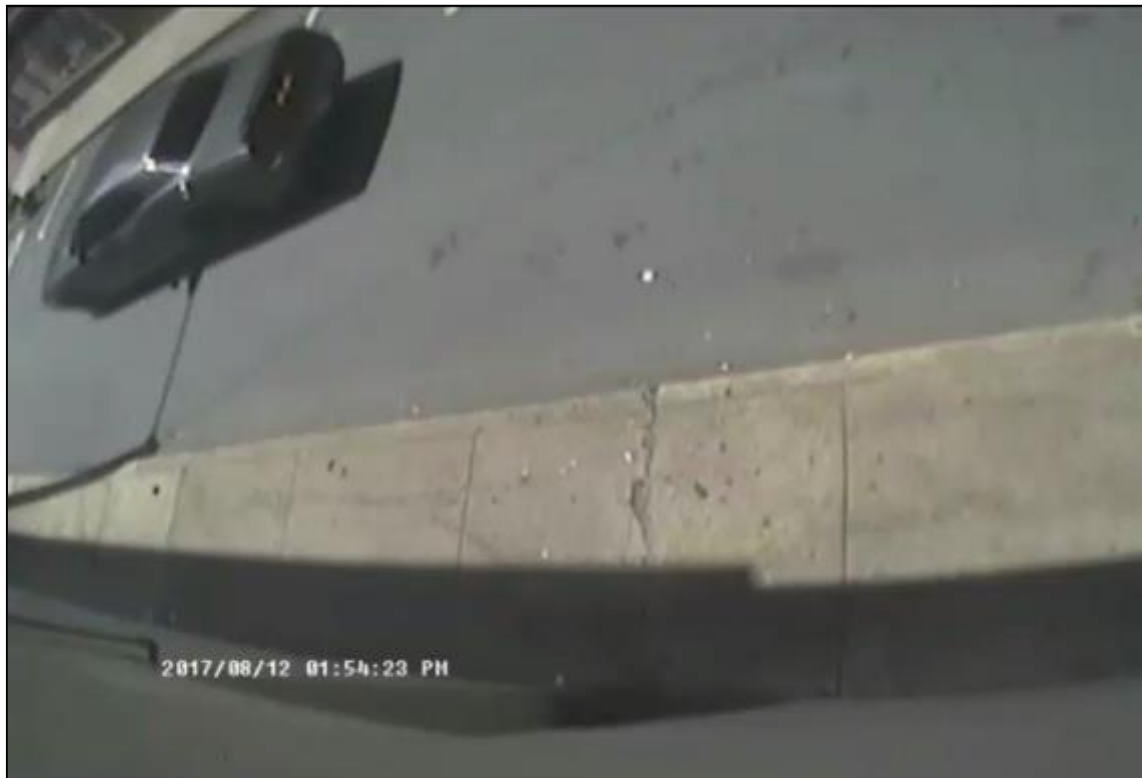
- c. The Challenger then backed up Fourth Street towards Market Street and was visible a second time in the Red Pump video at about 1:54:23 p.m.

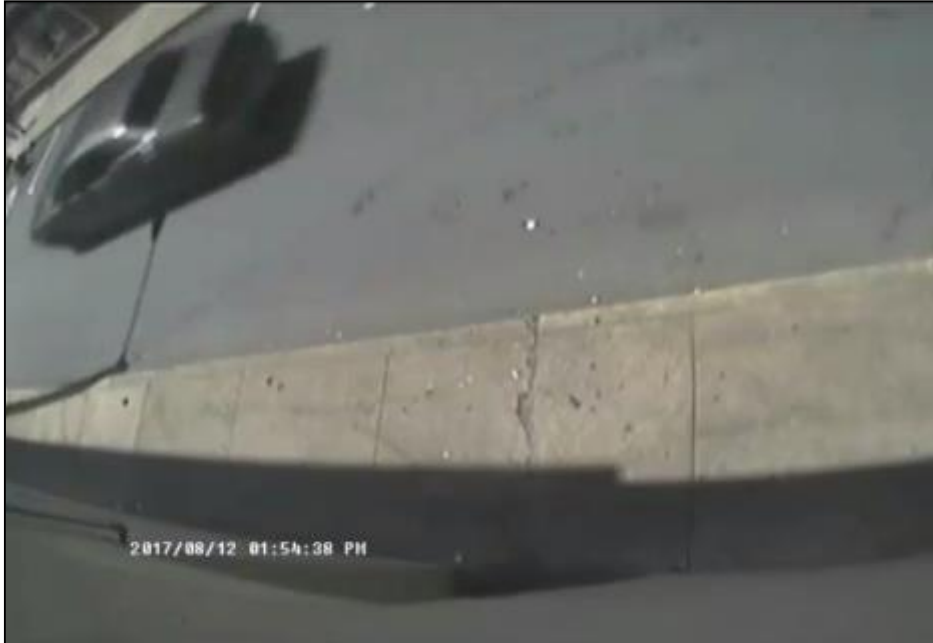
- d. The Challenger was seen a third time in the Red Pump video driving down Fourth Street towards Main Street at a high rate of speed moments later at 1:54:38 p.m.

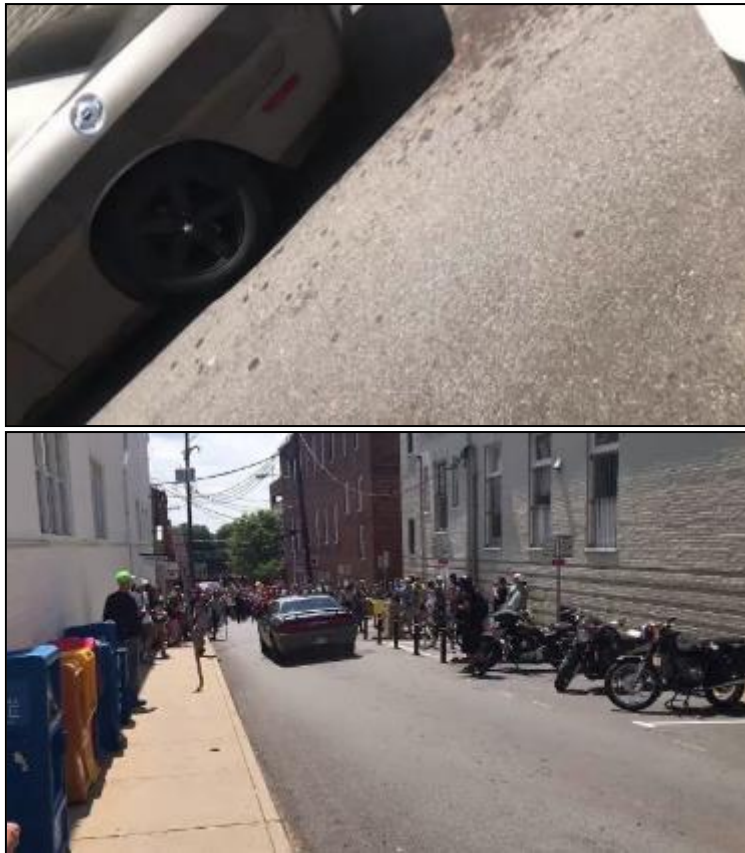
- e. The Challenger is seen crossing Main Street traveling at a high rate of speed and continues past several bollards (black posts) on the west side of the street.

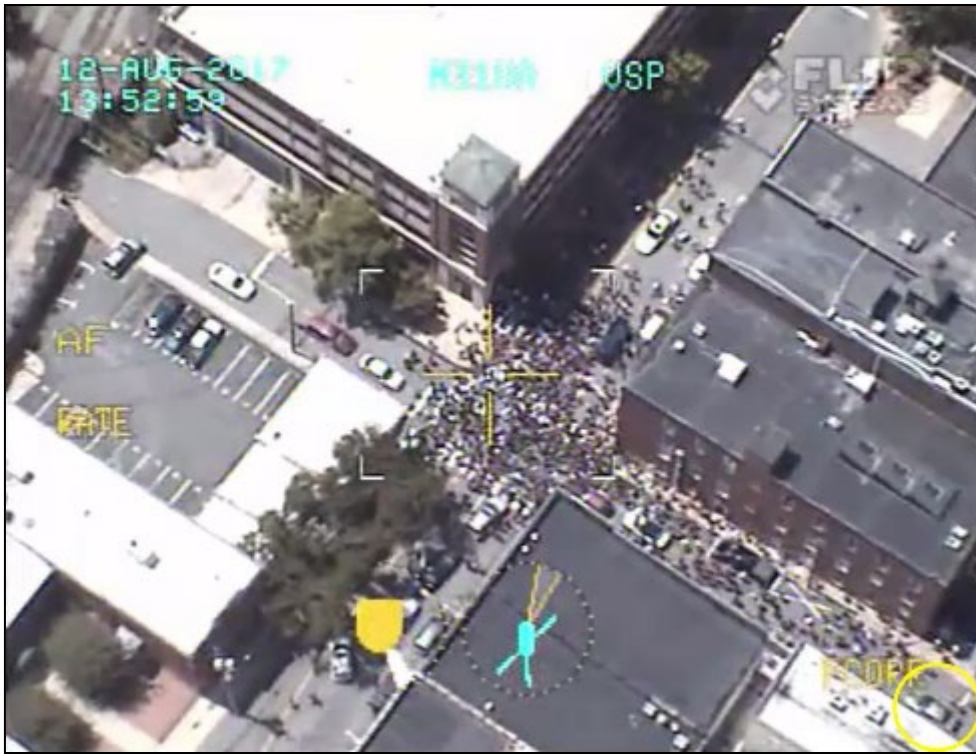
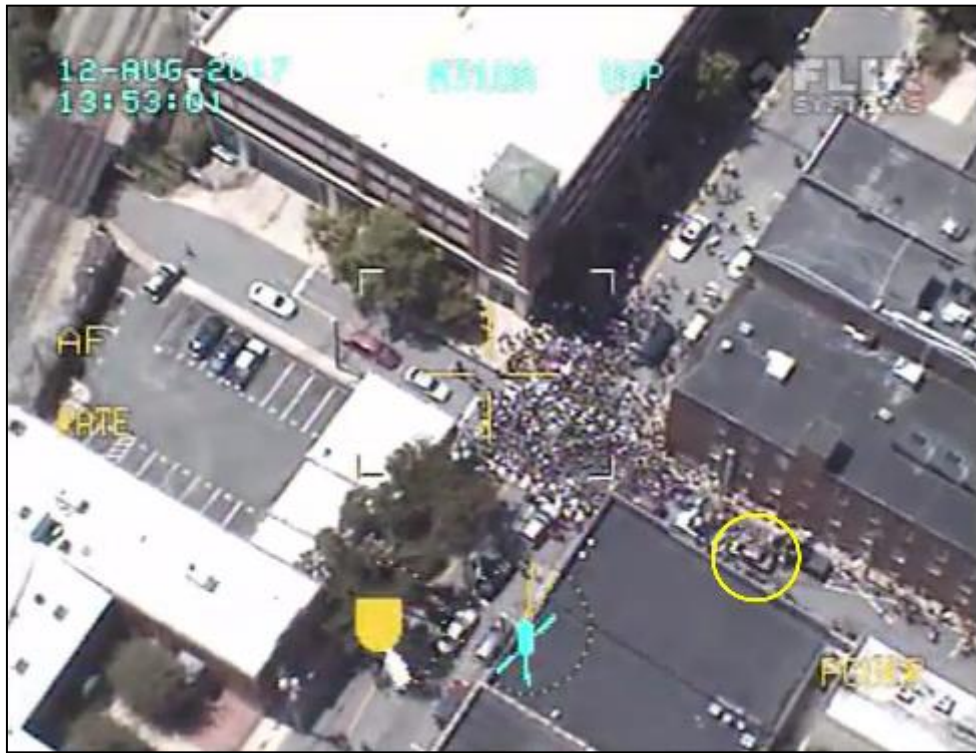
- f. The Challenger then comes into view in the helicopter video south of the bollards where it can be followed up to the time of impact.

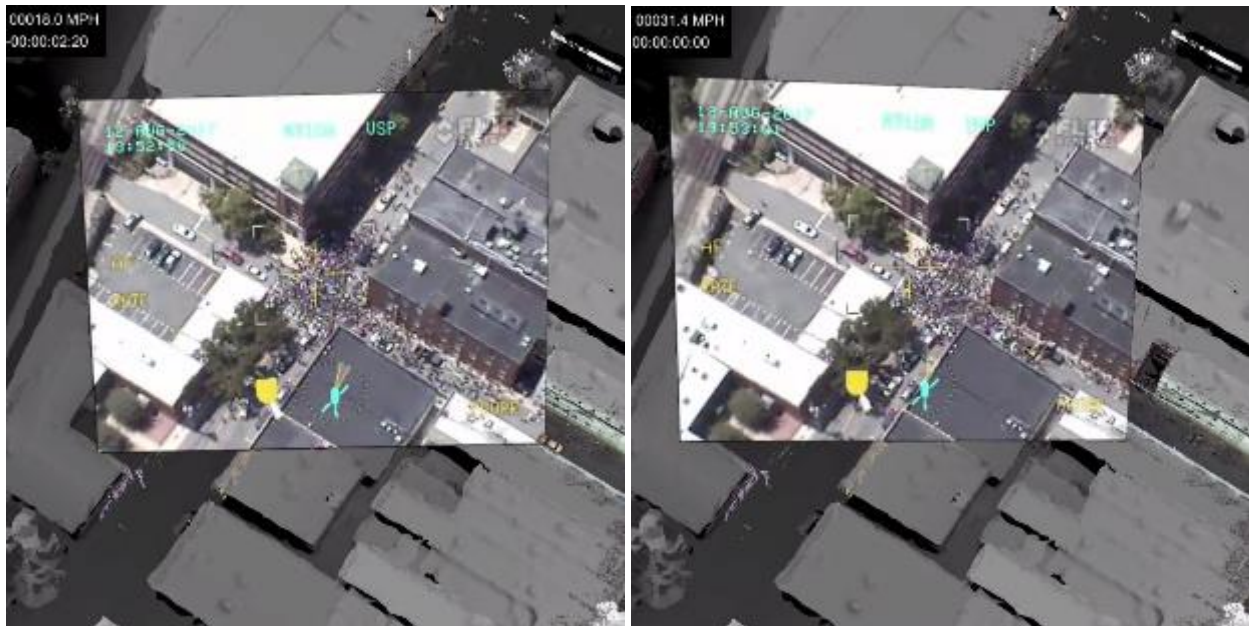
1. The Challenger enters the video traveling approximately 18 mph and speeds up to approximately 31 mph at impact with the Camry. These speeds were determined using the stabilized video. The first frame below shows the Challenger entering the frame at 18 mph. The second frame shows the Challenger traveling 31.4 mph at impact. The video accompanies this report.

- a. **Speed:** It was determined through photo and video analysis that Mr. Fields accelerated at nearly full throttle from 13 mph to more than 31 mph at impact with the Camry. Had he not accelerated, the pedestrians would have had more time to move out of the Challenger's path.

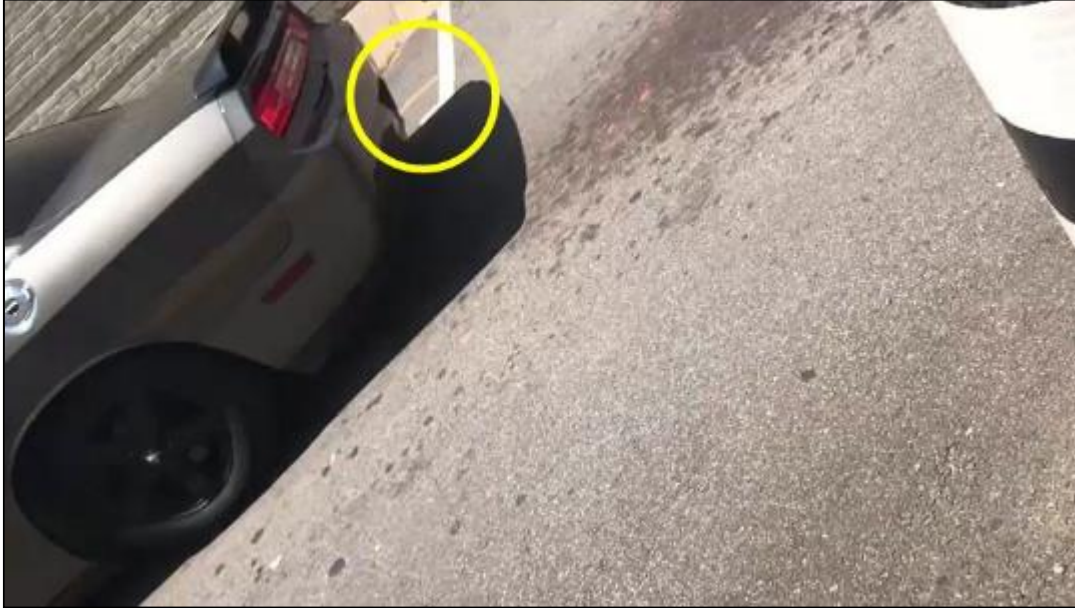
- i. As the Challenger came off the speed bump south of Main Street, it was headed towards the bollards that surrounded the bicycle area. The right side of the Challenger is seen up against the white lines that designate the parking spots on the west side of Fourth Street.

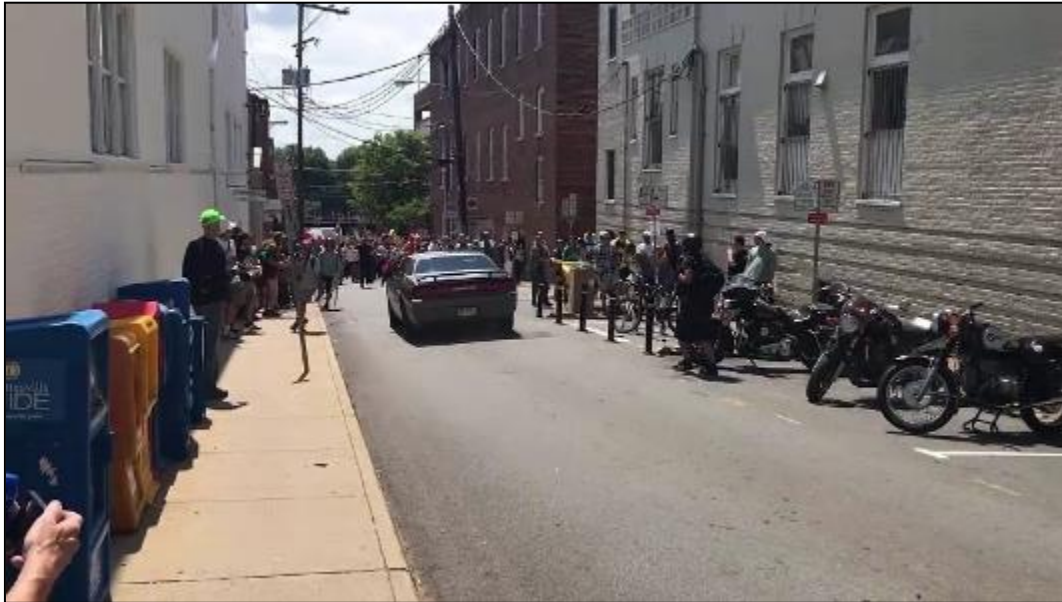
- ii. The Challenger was then steered to the left to avoid the bollards surrounding the bicycle parking area.

- c. **Steering:** As Mr. Fields passed the bollards, pedestrians jumped out of the Challenger's path towards the sidewalk on both sides of Fourth Street. Several pedestrians were walking adjacent to the pickup truck on the west side of the street and were not able to get to the sidewalk. Mr. Fields steered to the right, towards these pedestrians who did not have an escape route. Had Mr. Fields not steered to the right, he would not have impacted these pedestrians.

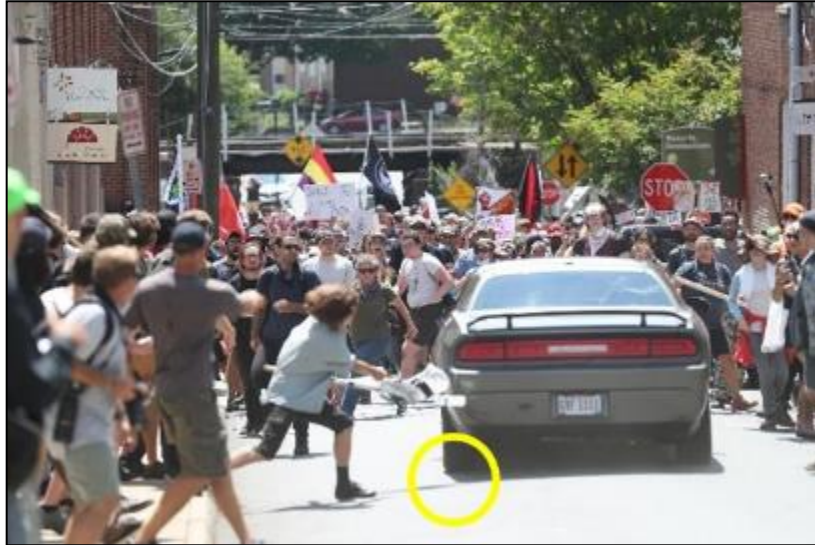
- e. **Pedestrian with Flagpole:** Analysis of the evidence shows that as Mr. Fields was speeding towards the pedestrians, a pedestrian swung a flagpole at the back of the Challenger as it passed him, but he missed and the car was not impacted by the flagpole. Notice that the shadow from the flagpole shows that the pole missed the Challenger. Also, the flagpole's path is not impeded by the Challenger.

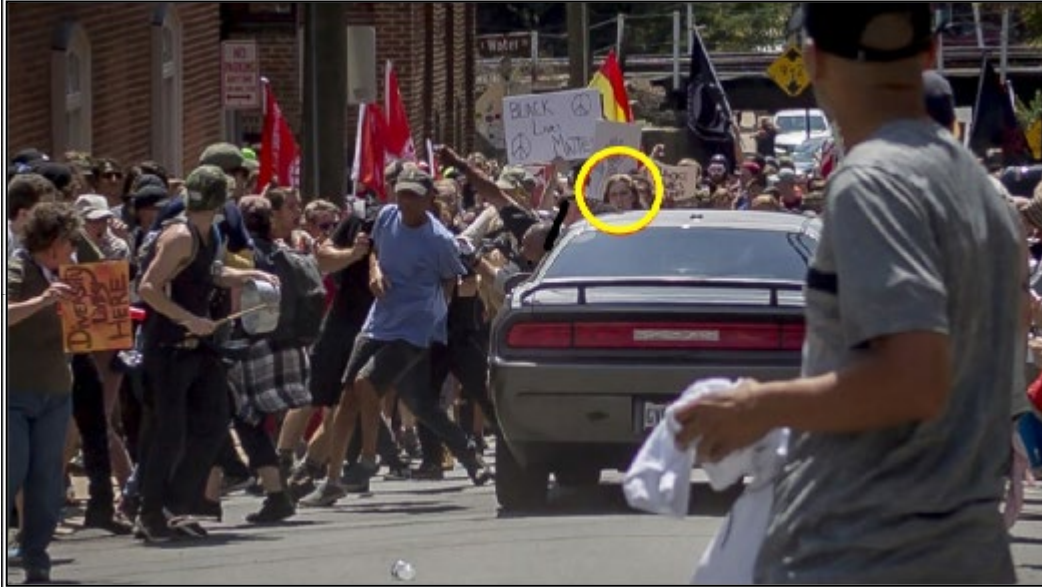
- a. Elizabeth Sines – Ms. Sines was walking north on Fourth Street when she saw the Challenger. She escaped to the east sidewalk when the Challenger was a few feet away from impacting her.

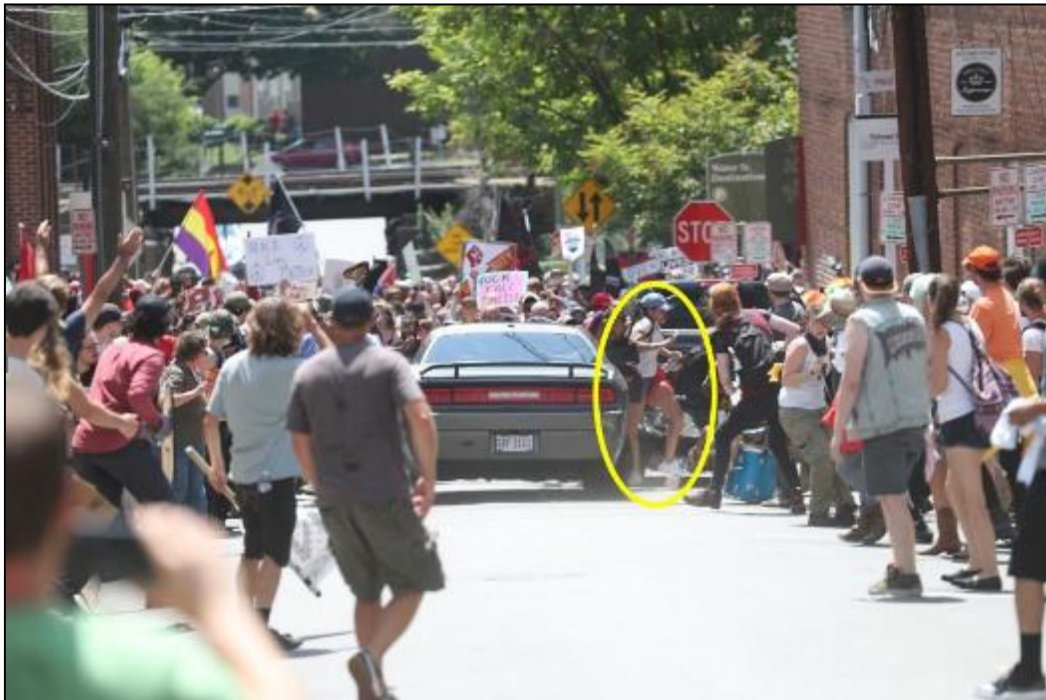
- b. Marissa Blair – Ms. Blair was walking in front of Marcus Martin adjacent to the pickup truck parked on the west side of the street. She was pushed out of the Challenger's path towards the sidewalk by Marcus Martin.

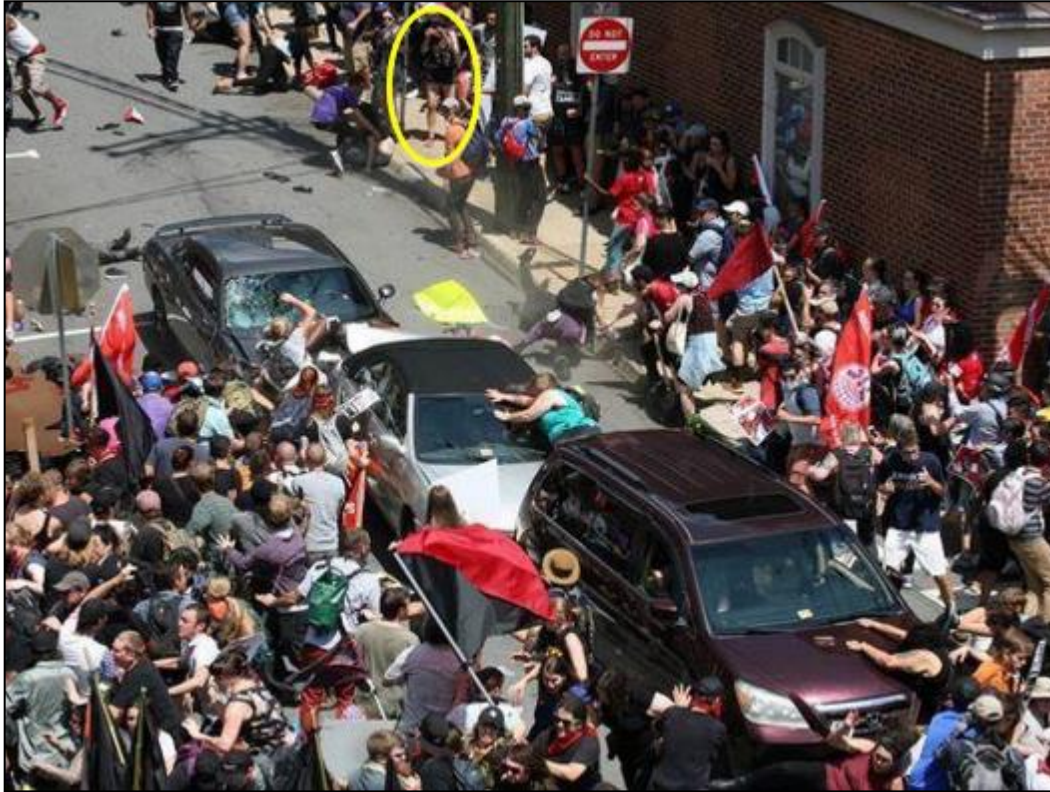
- c. April Muniz – Ms. Muniz was walking on the east side of the street at the time of the crash and is pictured on the east sidewalk as the Challenger impacted the Camry.

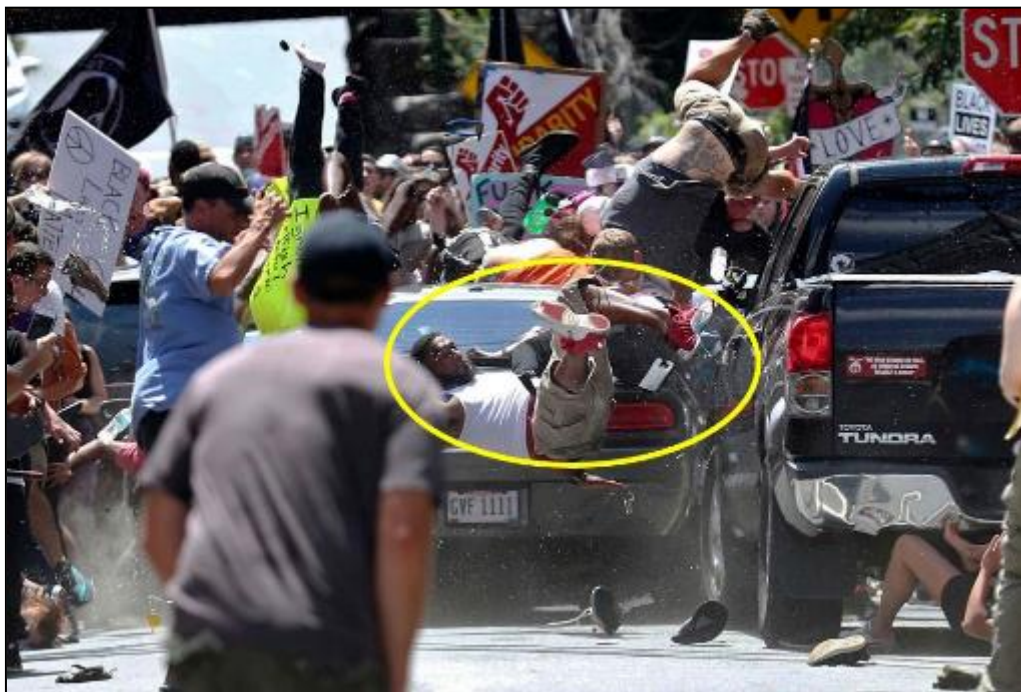
- d. Marcus Martin – Mr. Martin was impacted by the Challenger and went over the top of the Challenger.

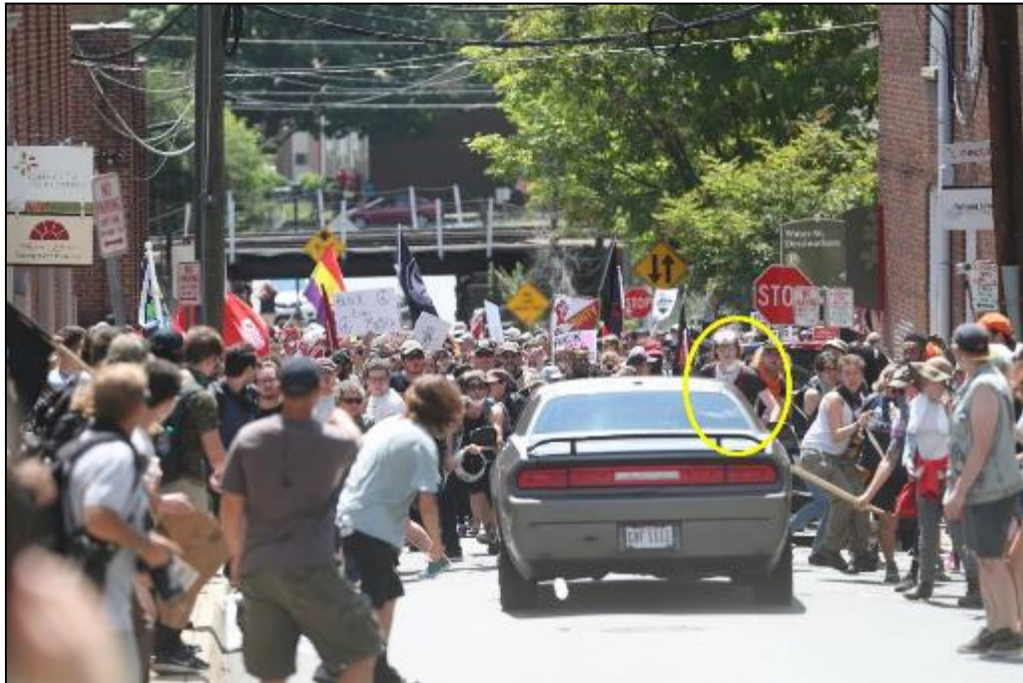
- f. Chelsea Alvarado – Ms. Alvarado was carrying a drum. She and the drum were impacted by the Challenger and thrown to the west.

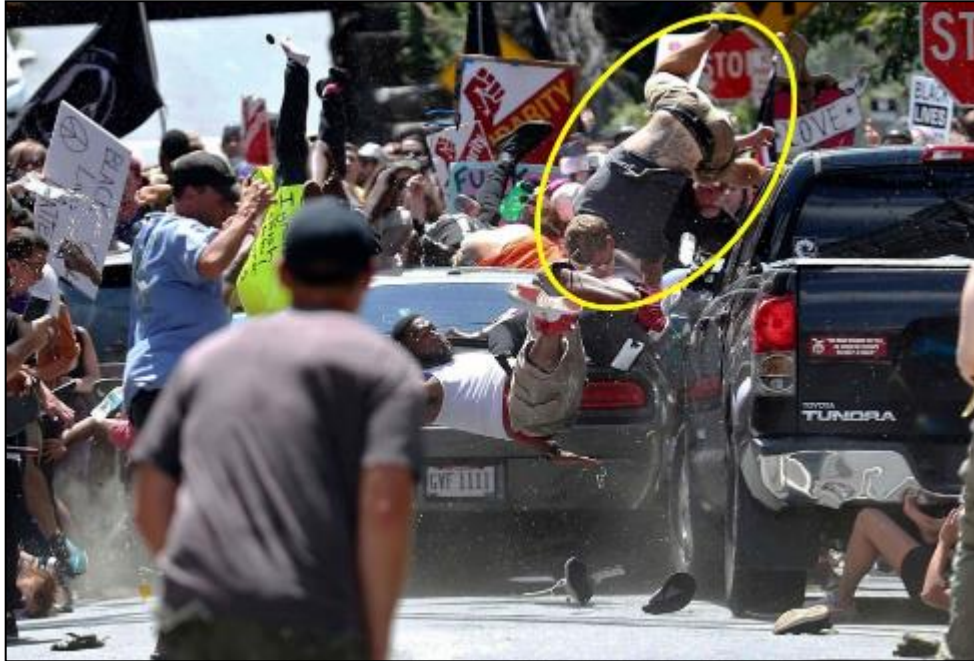
- g. Thomas Baker – Mr. Baker was impacted by the Challenger, and he went over the top of the Challenger.

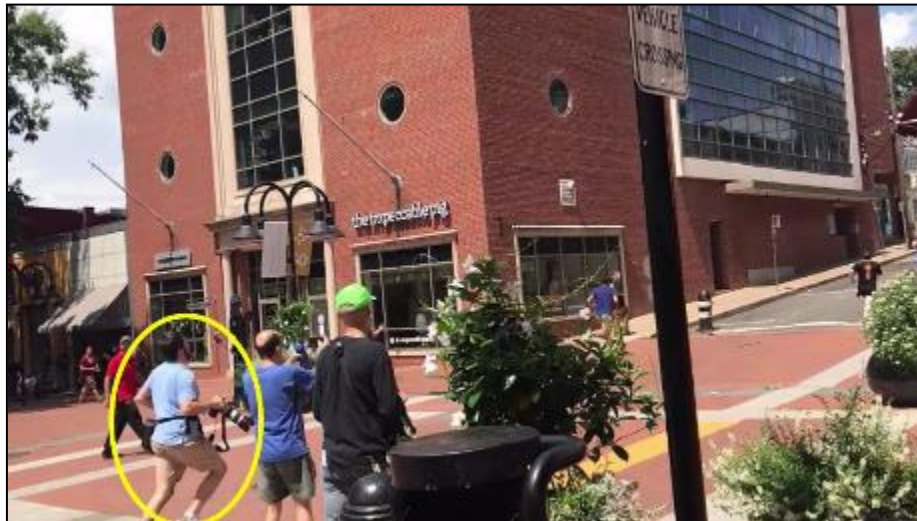
- h. Ryan Kelly – Mr. Kelly was north of the area of the collision and photographed the Challenger as it traveled down Fourth Street and then back up towards Market Street.
