Forensic Engineering and Visualization

July 20, 2020

RE: *Crash Reconstruction for Sines v. Kessler*

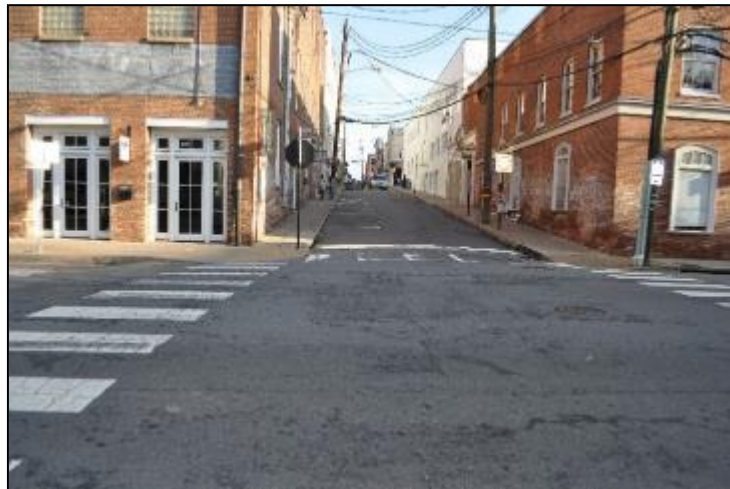
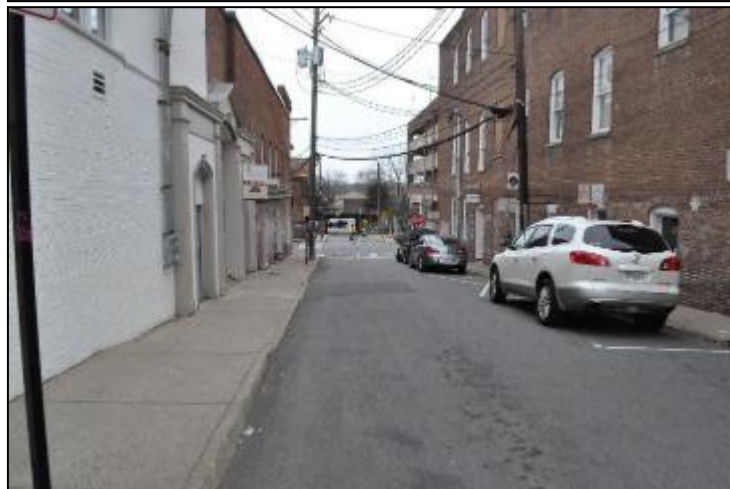
Kineticorp Site Inspection: On February 6, 2019, my team and I inspected, documented, scanned, and photographed the site of the subject crash. During the site inspection, we documented the intersection where the crash occurred. The photographs below were taken during the inspection of the crash site. The photographs depict the subject intersection, facing northbound and southbound, respectively.

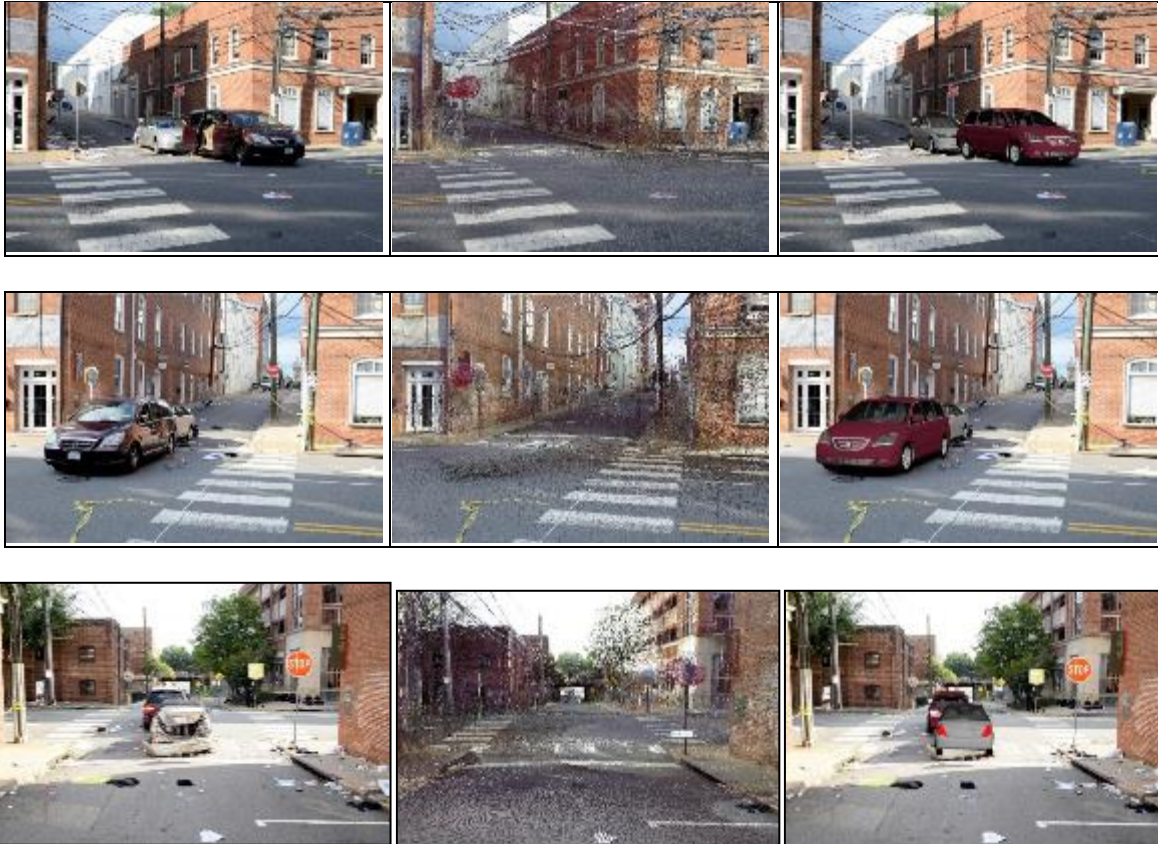
The following images contain a sampling of this photogrammetric analysis. The first image in each row is a photograph taken during the police investigation on the day of the crash. The second image of each row shows the scan data gathered during our scene inspection that has been aligned to the police photo. The third image depicts the photograph overlaid with the 3D computer models of the crash vehicles.

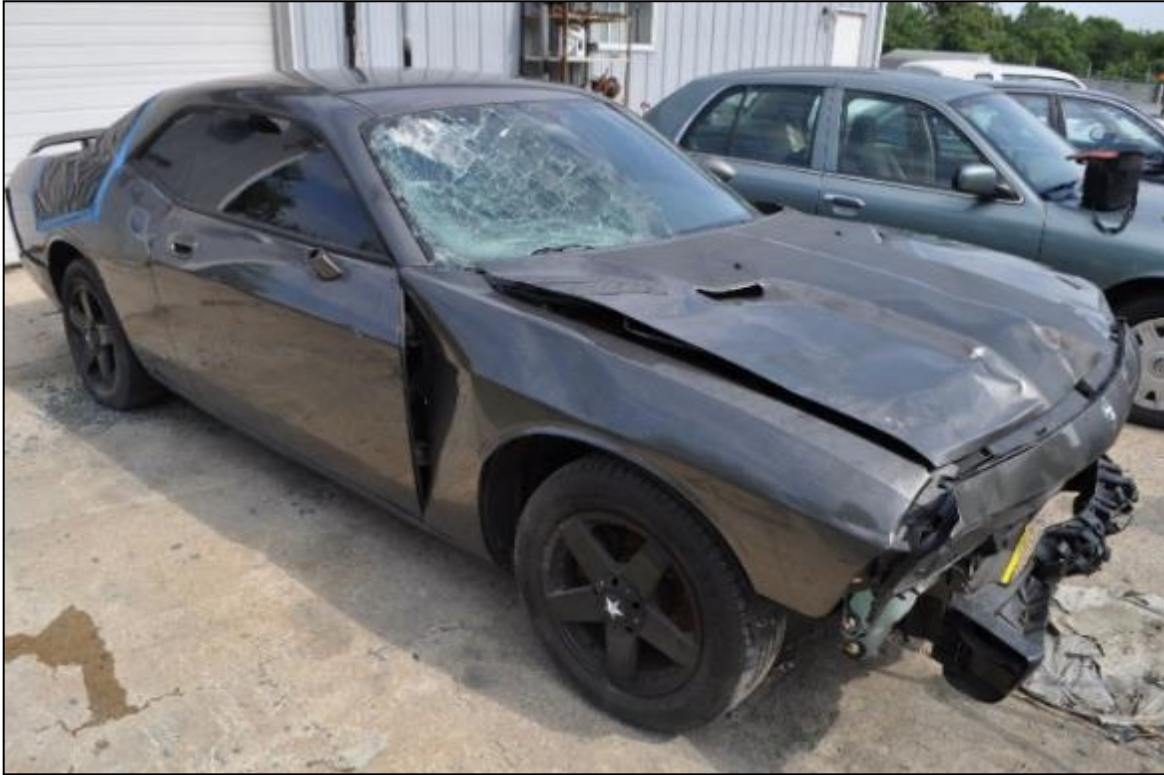
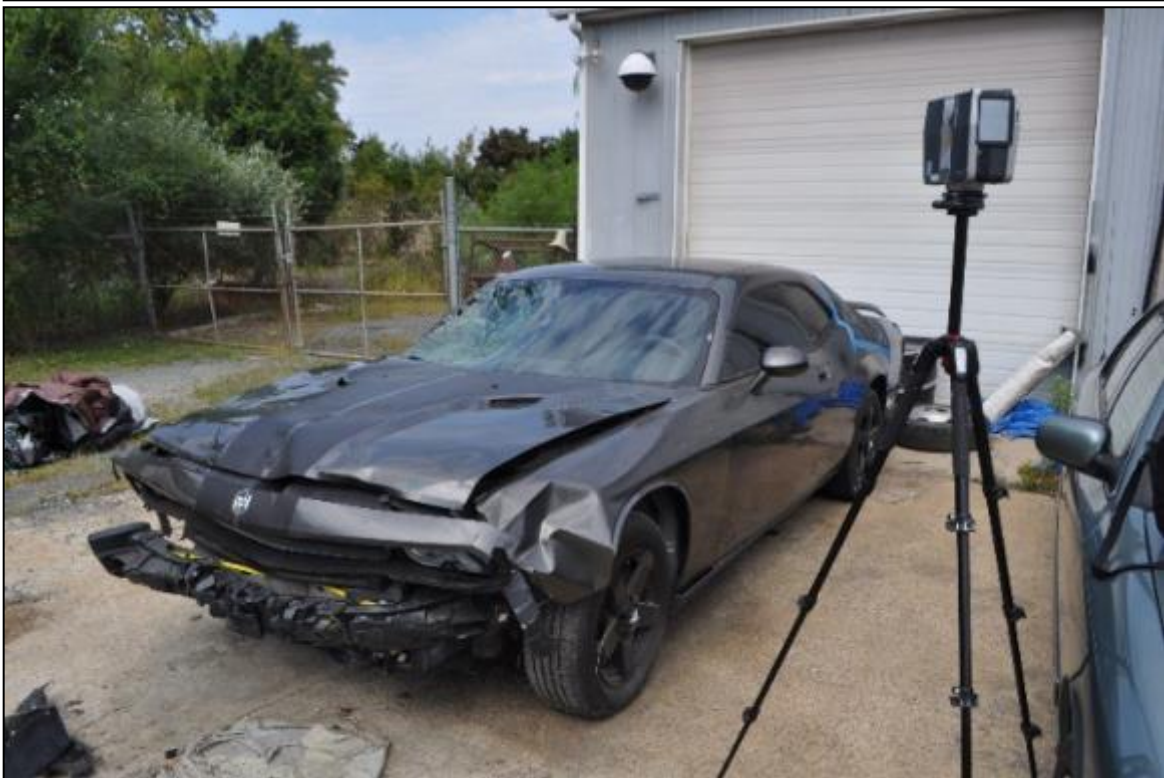
Dodge Challenger: The subject vehicle was a 2010 model year Dodge Challenger, 2-door sedan (VIN – 2B3CJ4DV8AH111921). It was equipped with a 3.5-liter, six-cylinder, 24-valve engine, and a four-speed automatic transmission. The Challenger was inspected by Kineticorp, photographed, and laser scanned using a Faro Focus scanner. As seen in the photographs, the Challenger sustained direct contact damage to the front portion of the vehicle and windshield as a result of the collision, which is consistent with photos and videos taken the day of the crash.

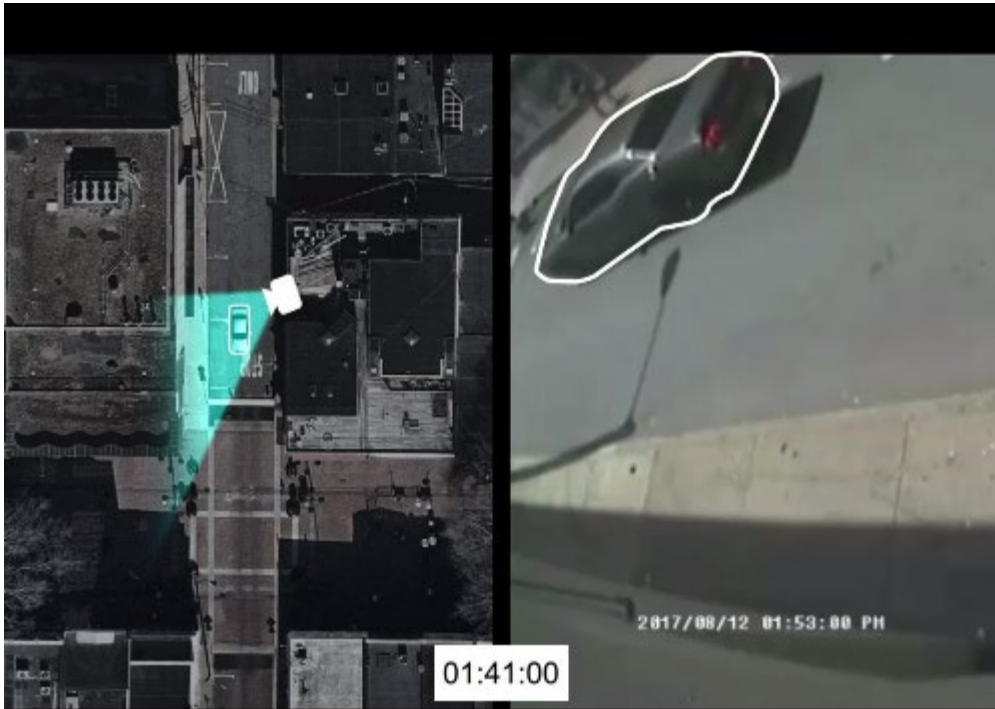
Dodge Visible in the Red Pump video north of the pedestrian mall, driving south toward the mall

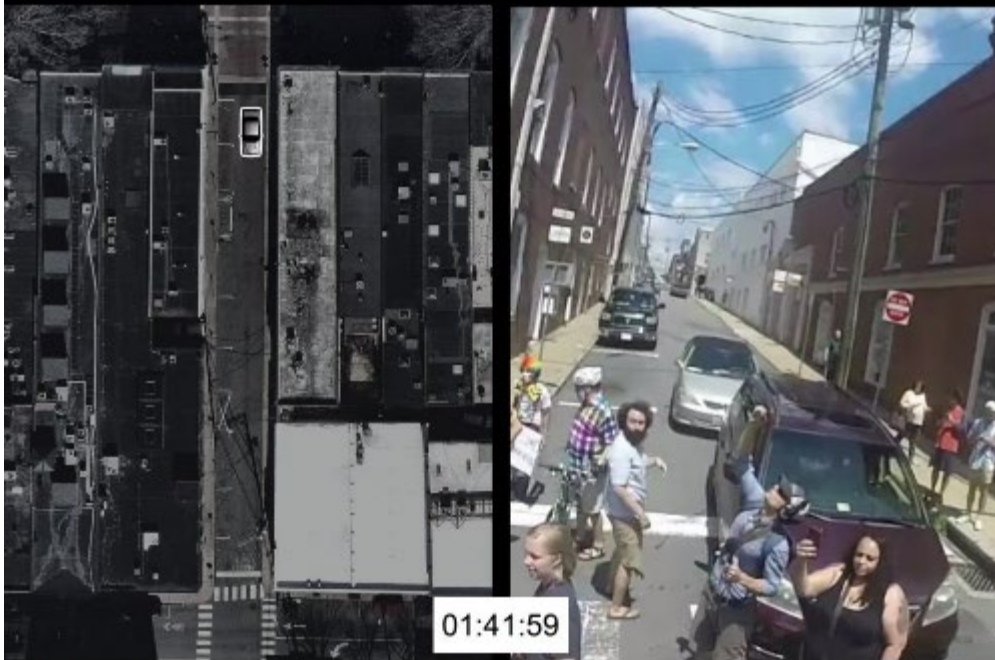
Dodge Visible in the video south of the pedestrian mall sitting at top of hill

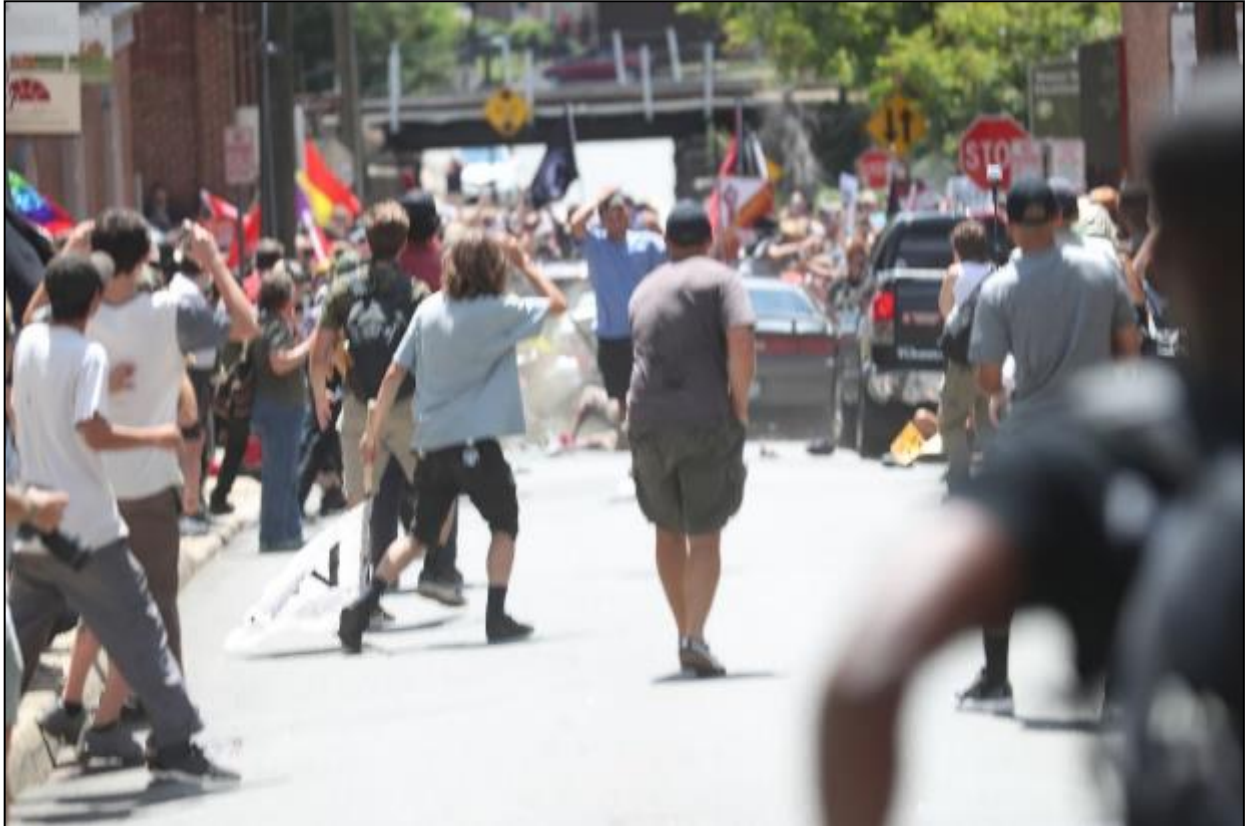
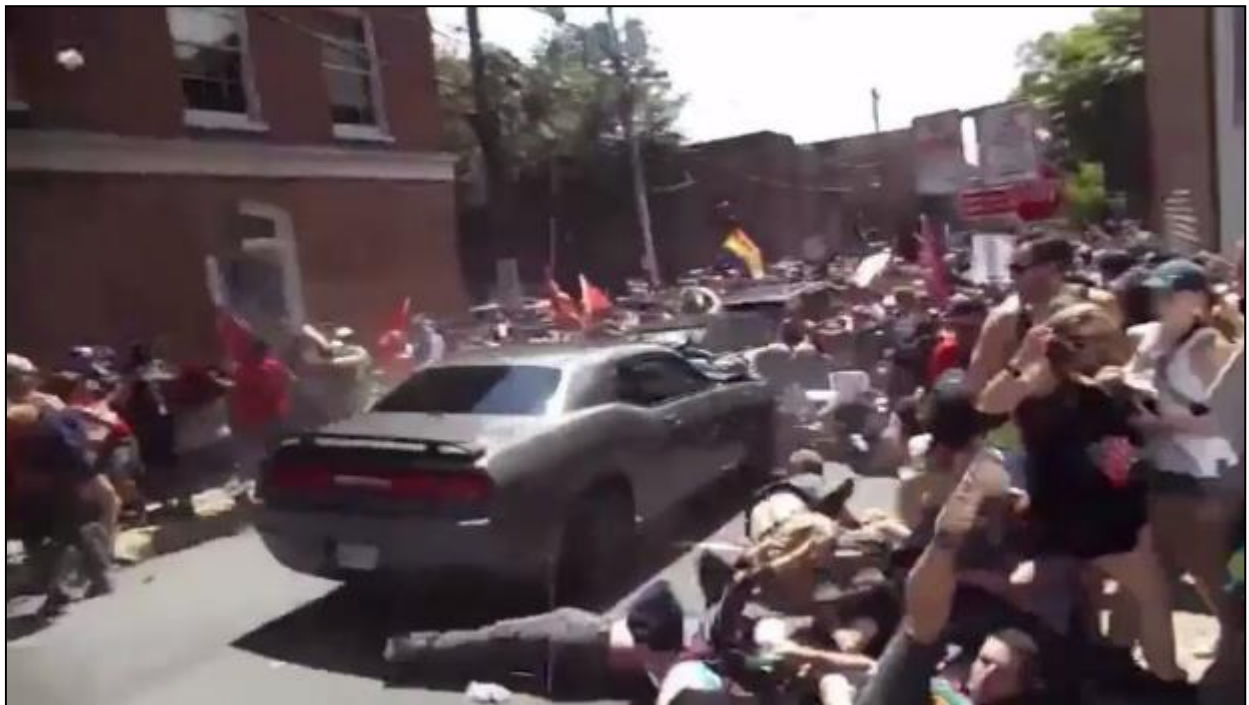
- ii. The Challenger's brake lights went off when the Challenger cleared the bicycle parking area and remained off as it accelerated and traveled up to impact with the Camry.
